Subject: Soils Testing Letter Report
Surfside Corner
2320 Southwest 21st Avenue
Cape Coral, Lee County, Florida
Strap #: 28-44-23-C4-05916.0000
Velocity Project Number 18-225

TEST PIT LOCATION PLAN

Surfside Corner

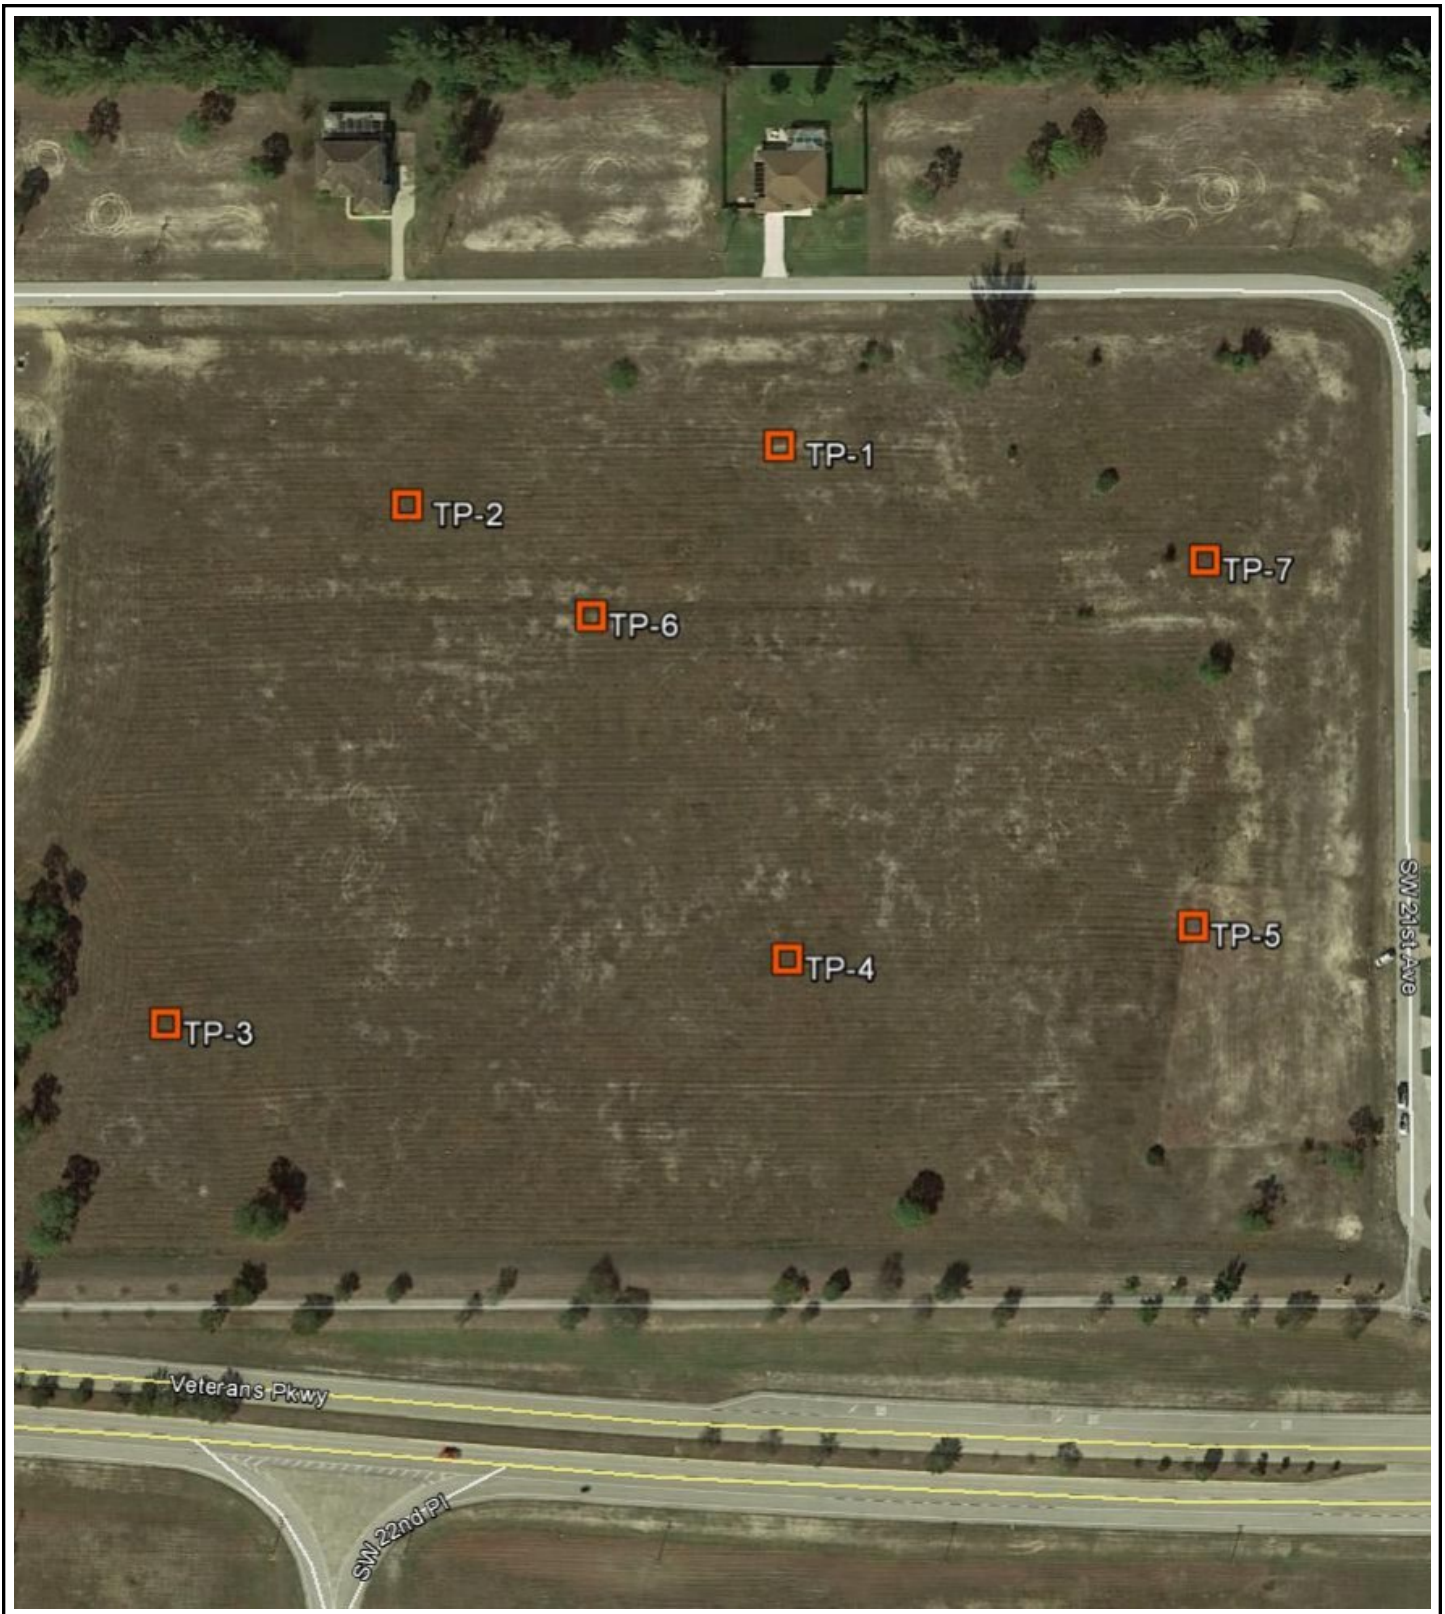
A total of seven (7) test pits (numbered TP-1 through TP-7) were performed adjacent to test boring locations where hard limestone was encountered. The test pits were performed using a Takeuchi TB2150 excavator and were backfilled upon completion. The subsurface soil conditions encountered in the test pits generally consist of sand (SP) with varying amounts of root and rock and a trace of silt from the existing ground surface to the termination depths of approximately 1.5 to 6 feet BGS. It should be noted that limestone boulders up to 26 inches in diameter were excavated in the test pits from the ground surface to the termination depths. Furthermore, refusal of the excavating equipment (Takeuchi TB2150 Excavator with a 36 inch bucket) was encountered at test pit TP-2 and TP-6 at 3 feet and 1.5 feet, respectively. Based on the test pits performed, it is likely that the refusal encountered within TP-2 and TP-6 was caused by boulders larger than 36 inches in diameter.

It should be noted that the test results indicate the subsurface soil conditions at the boring/test pit locations only and the possibility that hard rock may exist at other depths or in other locations cannot be ruled out. Excavation contractors should not rely on Velocity's report in preparing their bids for this project. Velocity recommends that the excavation contractor(s) perform test pits at the site to confirm that the subsurface conditions they encounter are consistent with those presented in Velocity's boring logs and/or record of test pits. Detailed records of each test pit and a Test Pit Location Plan are attached to this report.
