PRELIMINARY GEOTECHNICAL EXPLORATION REPORT

ORCHARDS AT NAPLES ROAD APARTMENTS
399 & 333 NAPLES ROAD
HENDERSONVILLE, NORTH CAROLINA

BLE Project Number 24-24544

March 31, 2025

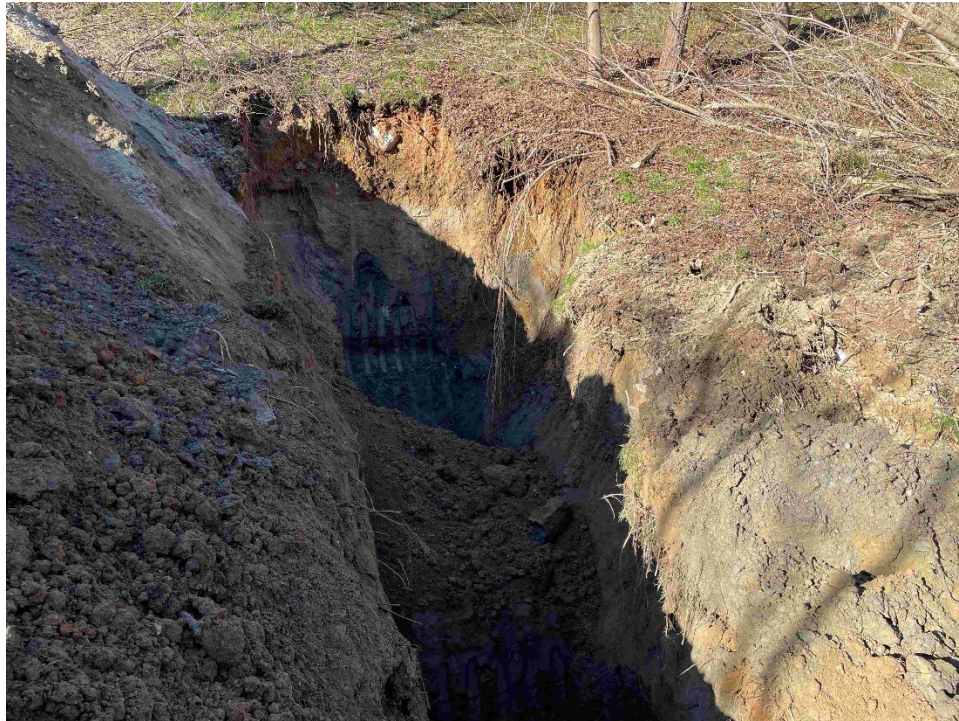
TEST PIT LOG

Job Name: Orchards at Naples		Location: TP-1		
Job Number: 24-24544		Date Logged: 2/17/2025		
Approximate Elevation:		Logged By: Tanner Whitesell		
Depth (Feet)		Stratum Description	DCP DATA	
From	To		Depth	Blows
0'	4"	Topsoil/Roots	-	-
4"	2'	Bricks, concrete etc. – (Fill)	-	-
2'	6'	Tan and gray, moist, clayey sand (SC) – (Alluvium)	-	-
Remarks and Notes: Test pit terminated at 6 feet. Measured at the toe of the slope Groundwater was encountered 5 feet from the uphill side of the test pit. Test pit backfilled with excavated material.

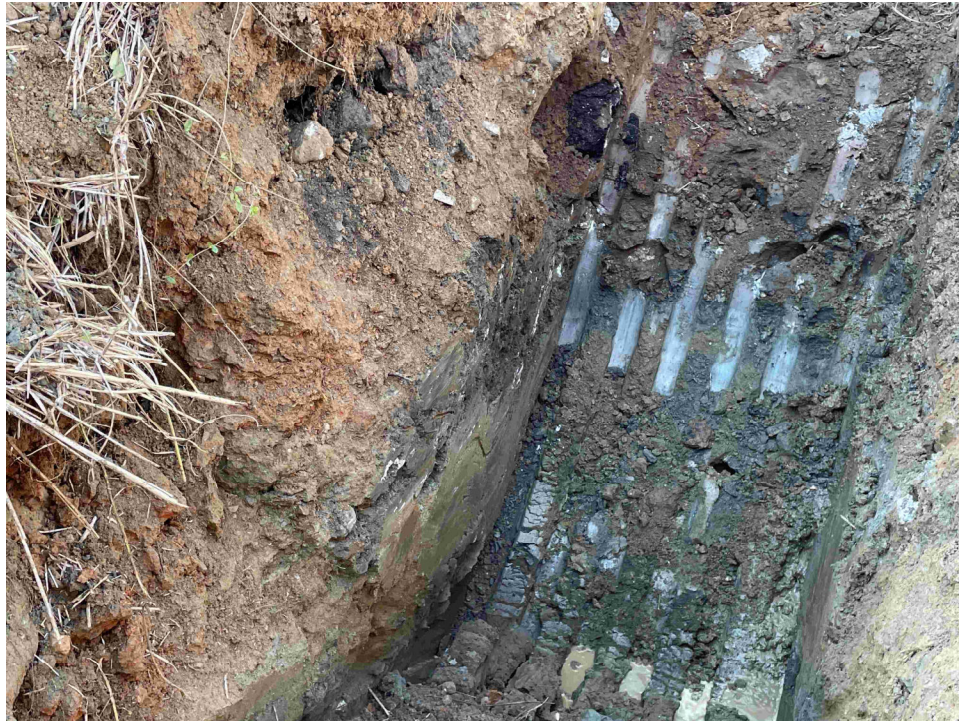
TEST PIT LOG

Job Name: Orchards at Naples		Location: TP-2		
Job Number: 24-24544		Date Logged: 2/17/2025		
Approximate Elevation:		Logged By: Tanner Whitesell		
Depth (Feet)		Stratum Description	DCP DATA	
From	To		Depth	Blows
0'	3"	Topsoil/Roots	-	-
3"	3'	Brown, moist, silty sand (SM) with construction debris – (Fill)	-	-
3'	6'	Gray, wet, sandy silt (ML) with construction debris – (Fill)	-	-
Remarks and Notes: Test pit terminated at 6 feet. Surface water was observed under the root mat. Groundwater was not encountered at the time of test pits. Test pit backfilled with excavated material.

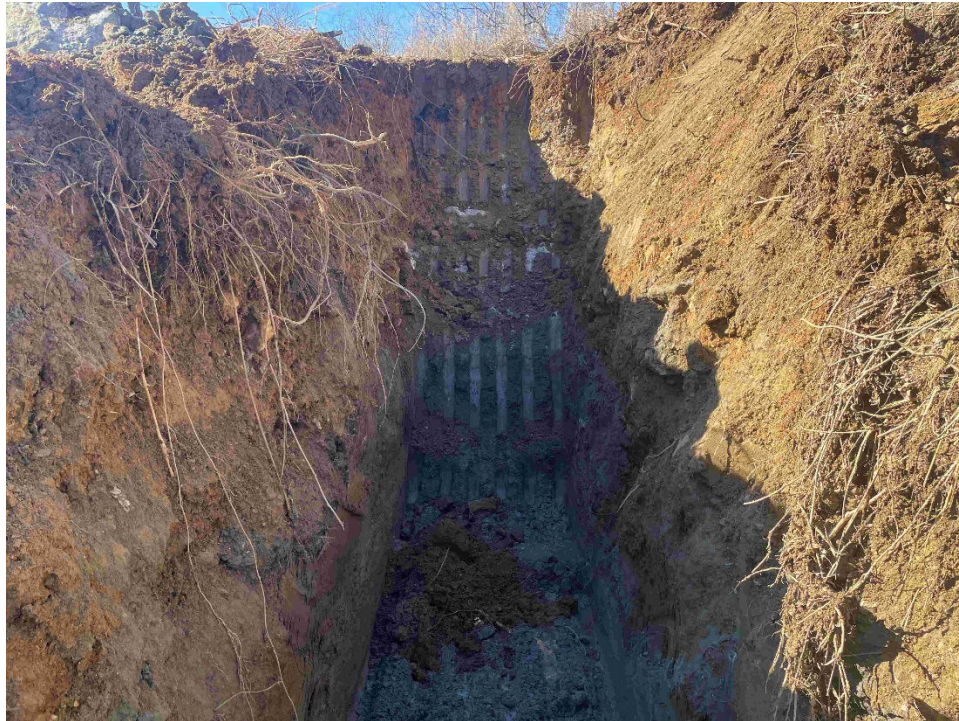
TEST PIT LOG

Job Name: Orchards at Naples		Location: TP-3		
Job Number: 24-24544		Date Logged: 2/17/2025		
Approximate Elevation:		Logged By: Tanner Whitesell		
Depth (Feet)		Stratum Description	DCP DATA	
From	To		Depth	Blows
0'	1'	Topsoil/Roots	-	-
1'	2'	Dark brown, moist, clayey silty sand (SM) with brick and asphalt observed – (Fill)	-	-
2'	4'	Blue and grey, clayey sand (SC) – (alluvium)	-	-
Remarks and Notes: Test pit terminated at 4 feet. Groundwater was not encountered at the time of test pits. Measurements taken at the toe of slope. Test pit backfilled with excavated material.

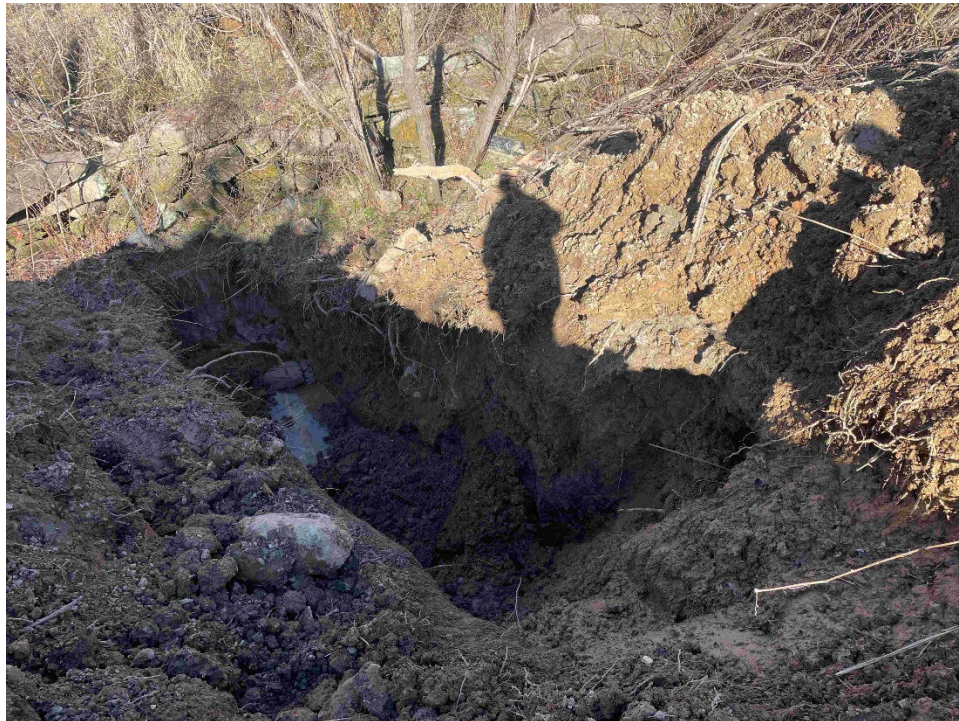
TEST PIT LOG

Job Name: Orchards at Naples		Location: TP-4		
Job Number: 24-24544		Date Logged: 2/17/2025		
Approximate Elevation:		Logged By: Tanner Whitesell		
Depth (Feet)		Stratum Description	DCP DATA	
From	To		Depth	Blows
0'	6"	Topsoil/Roots	-	-
6"	1.5'	Dark brown, moist, clayey sand (SC) with construction debris and trash observed – (Fill)	-	-
1.5'	3.5'	Grey silty sand (SM) – (Alluvium)	-	-
Remarks and Notes: Test pit terminated at 3.5 feet. Groundwater was encountered at 2 feet at time of excavation. Measurements taken at the toe of slope. Test pit backfilled with excavated material.

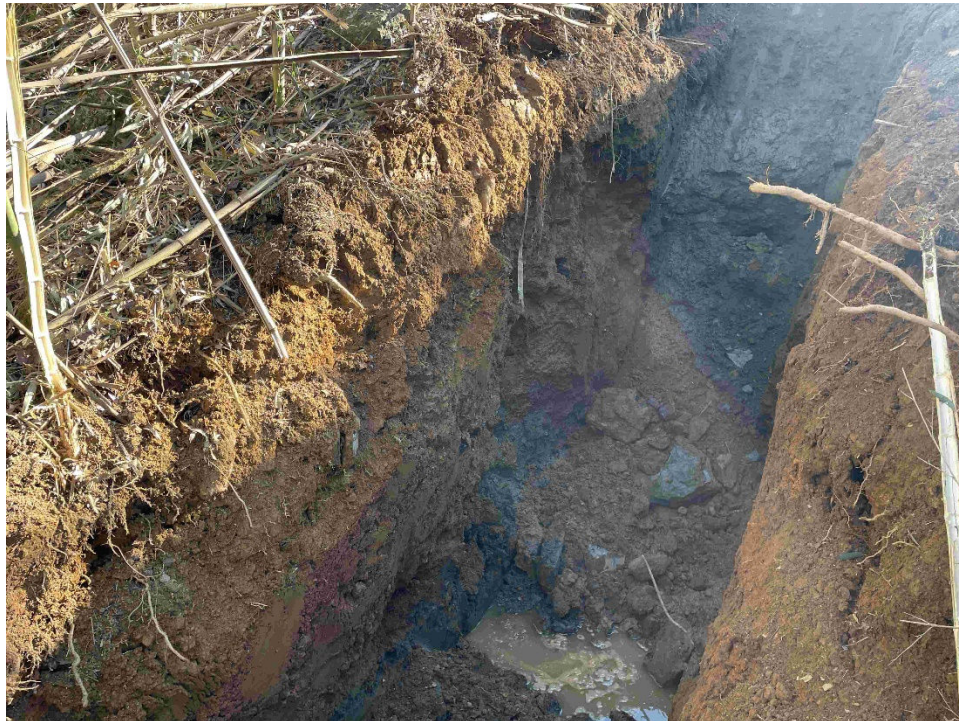
TEST PIT LOG

Job Name: Orchards at Naples		Location: TP-5		
Job Number: 24-24544		Date Logged: 2/17/2025		
Approximate Elevation:		Logged By: Tanner Whitesell		
Depth (Feet)		Stratum Description	DCP DATA	
From	To		Depth	Blows
0'	6"	Topsoil/Roots	-	-
6"	4'	Dark brown, moist, clayey silty sand (SC) with construction debris and trash observed (Fill)	-	-
4'	5'	Grey silty sand (SM) – (Alluvium)	-	-
Remarks and Notes: Test pit terminated at 5 feet. Groundwater was encountered at 4 feet at the time of excavation. Measurements taken at the toe of slope. Test pit backfilled with excavated material.

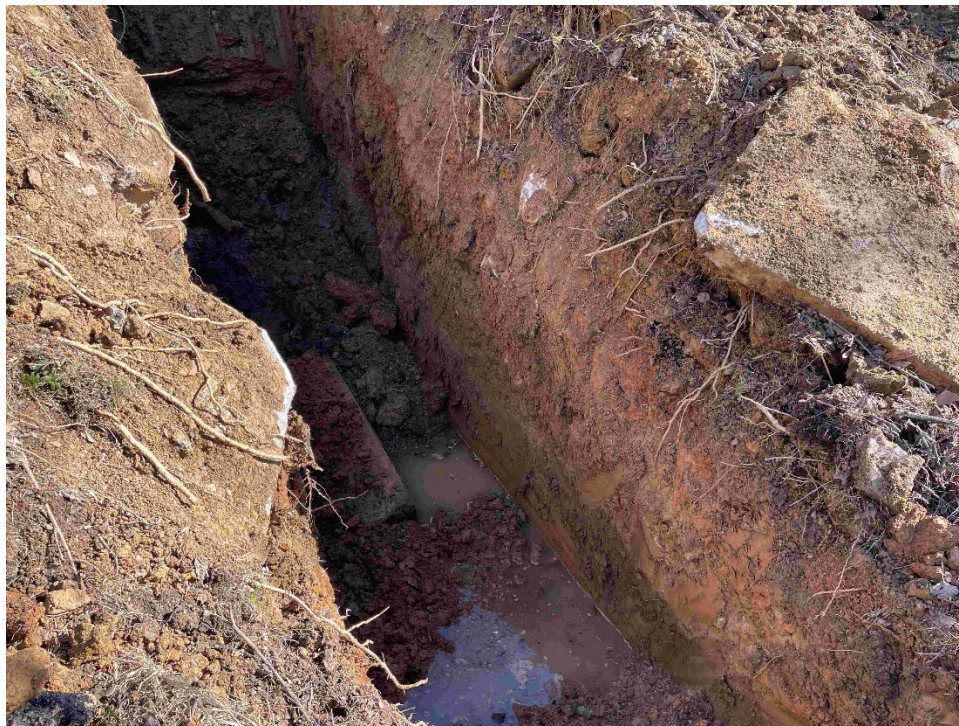
TEST PIT LOG

Job Name: Orchards at Naples		Location: TP-6		
Job Number: 24-24544		Date Logged: 2/17/2025		
Approximate Elevation:		Logged By: Tanner Whitesell		
Depth (Feet)		Stratum Description	DCP DATA	
From	To		Depth	Blows
0'	4"	Topsoil/Roots	-	-
4"	10'	Brown clayey silty sand (SM) with construction debris and concrete - (Fill)	-	-
Remarks and Notes: Test pit terminated at 10 feet. Groundwater was encountered at 5 feet at the time of excavation. Measurements taken at the toe of slope. Test pit backfilled with excavated material.

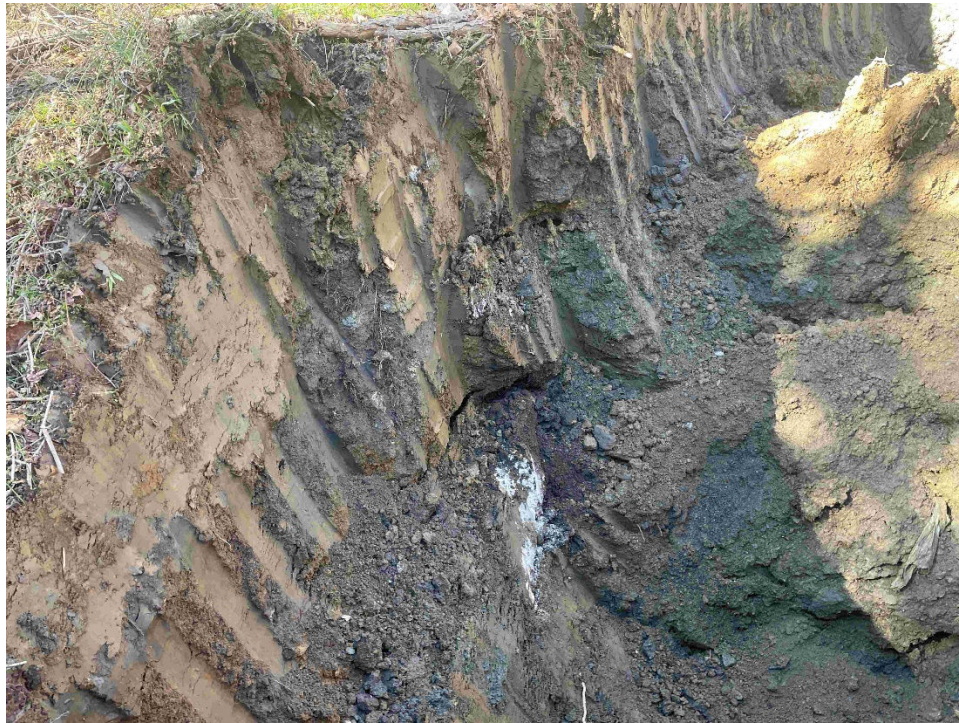
TEST PIT LOG

Job Name: Orchards at Naples		Location: TP-7		
Job Number: 24-24544		Date Logged: 2/17/2025		
Approximate Elevation:		Logged By: Tanner Whitesell		
Depth (Feet)		Stratum Description	DCP DATA	
From	To		Depth	Blows
0'	4"	Topsoil/Roots	-	-
4"	10'	Brown clayey silty sand (SM) with construction debris and concrete - (Fill)	-	-
Remarks and Notes: Test pit terminated at 10 feet. No groundwater was encountered at the time of excavation. Test pit backfilled with excavated material.

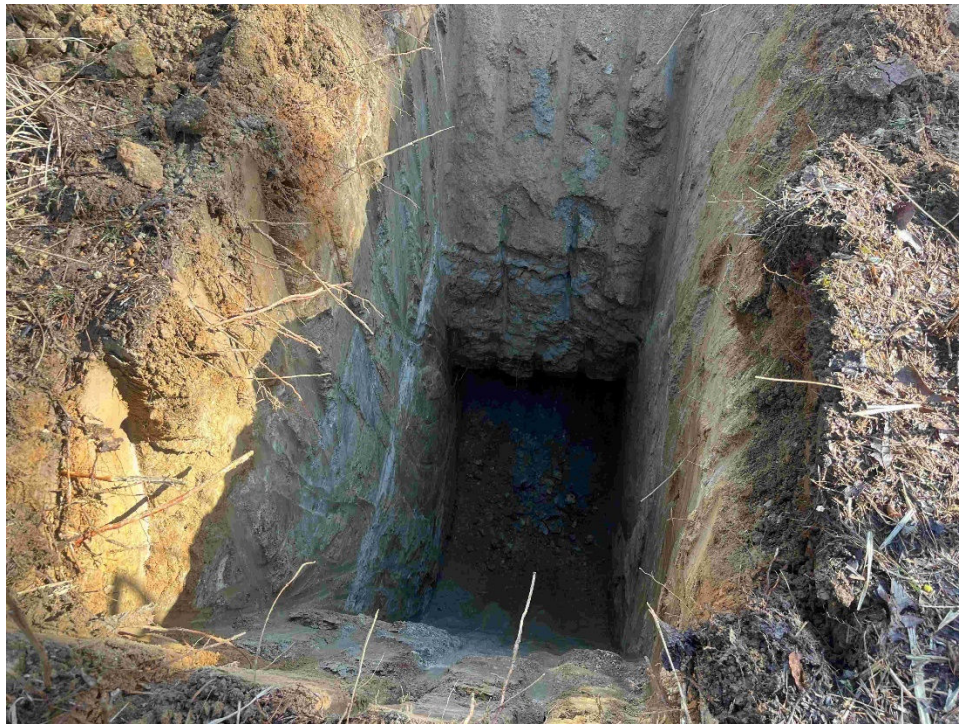
TEST PIT LOG

Job Name: Orchards at Naples		Location: TP-8		
Job Number: 24-24544		Date Logged: 3/4/25		
Approximate Elevation:		Logged By: Colm O'Doherty		
Depth (Feet)		Stratum Description	DCP DATA	
From	To		Depth	Blows
0'	3"	Topsoil/Leaves	-	-
3"	10'	Tan to gray, slightly moist, sandy, silt (ML) – (Residuum)	-	-
Remarks and Notes: Test pit terminated at 10 feet. No groundwater was encountered at the time of excavation. Test pit backfilled with excavated material.

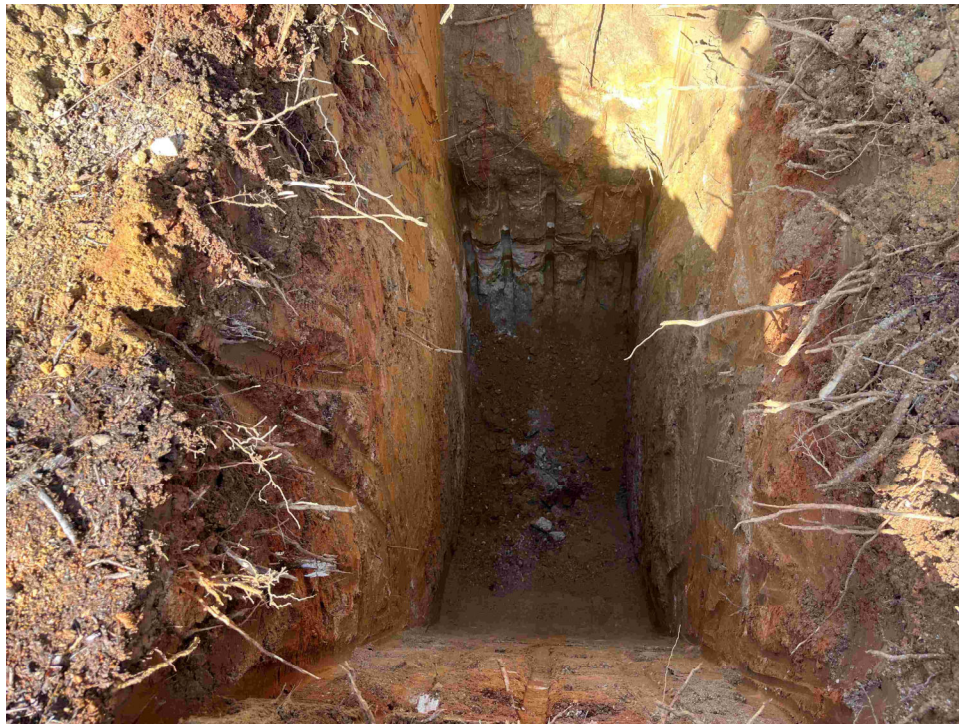
TEST PIT LOG

Job Name: Orchards at Naples		Location: TP-9		
Job Number: 24-24544		Date Logged: 3/4/25		
Approximate Elevation:		Logged By: Colm O'Doherty		
Depth (Feet)		Stratum Description	DCP DATA	
From	To		Depth	Blows
0'	3"	Topsoil/Leaves	-	-
3"	10.5'	Tan to gray, slightly moist, sandy, SILT (ML) – (Residuum)	-	-
Remarks and Notes: Test pit terminated at 10.5 feet. No groundwater was encountered at the time of excavation. Test pit backfilled with excavated material.
