**PRELIMINARY GEOTECHNICAL EXPLORATION
AND ENGINEERING SERVICES REPORT**

State Road 82 Development – Due Diligence
State Road 82
Fort Myers, Lee County, Florida

16 December 2021
YPC Project No. 21GY258

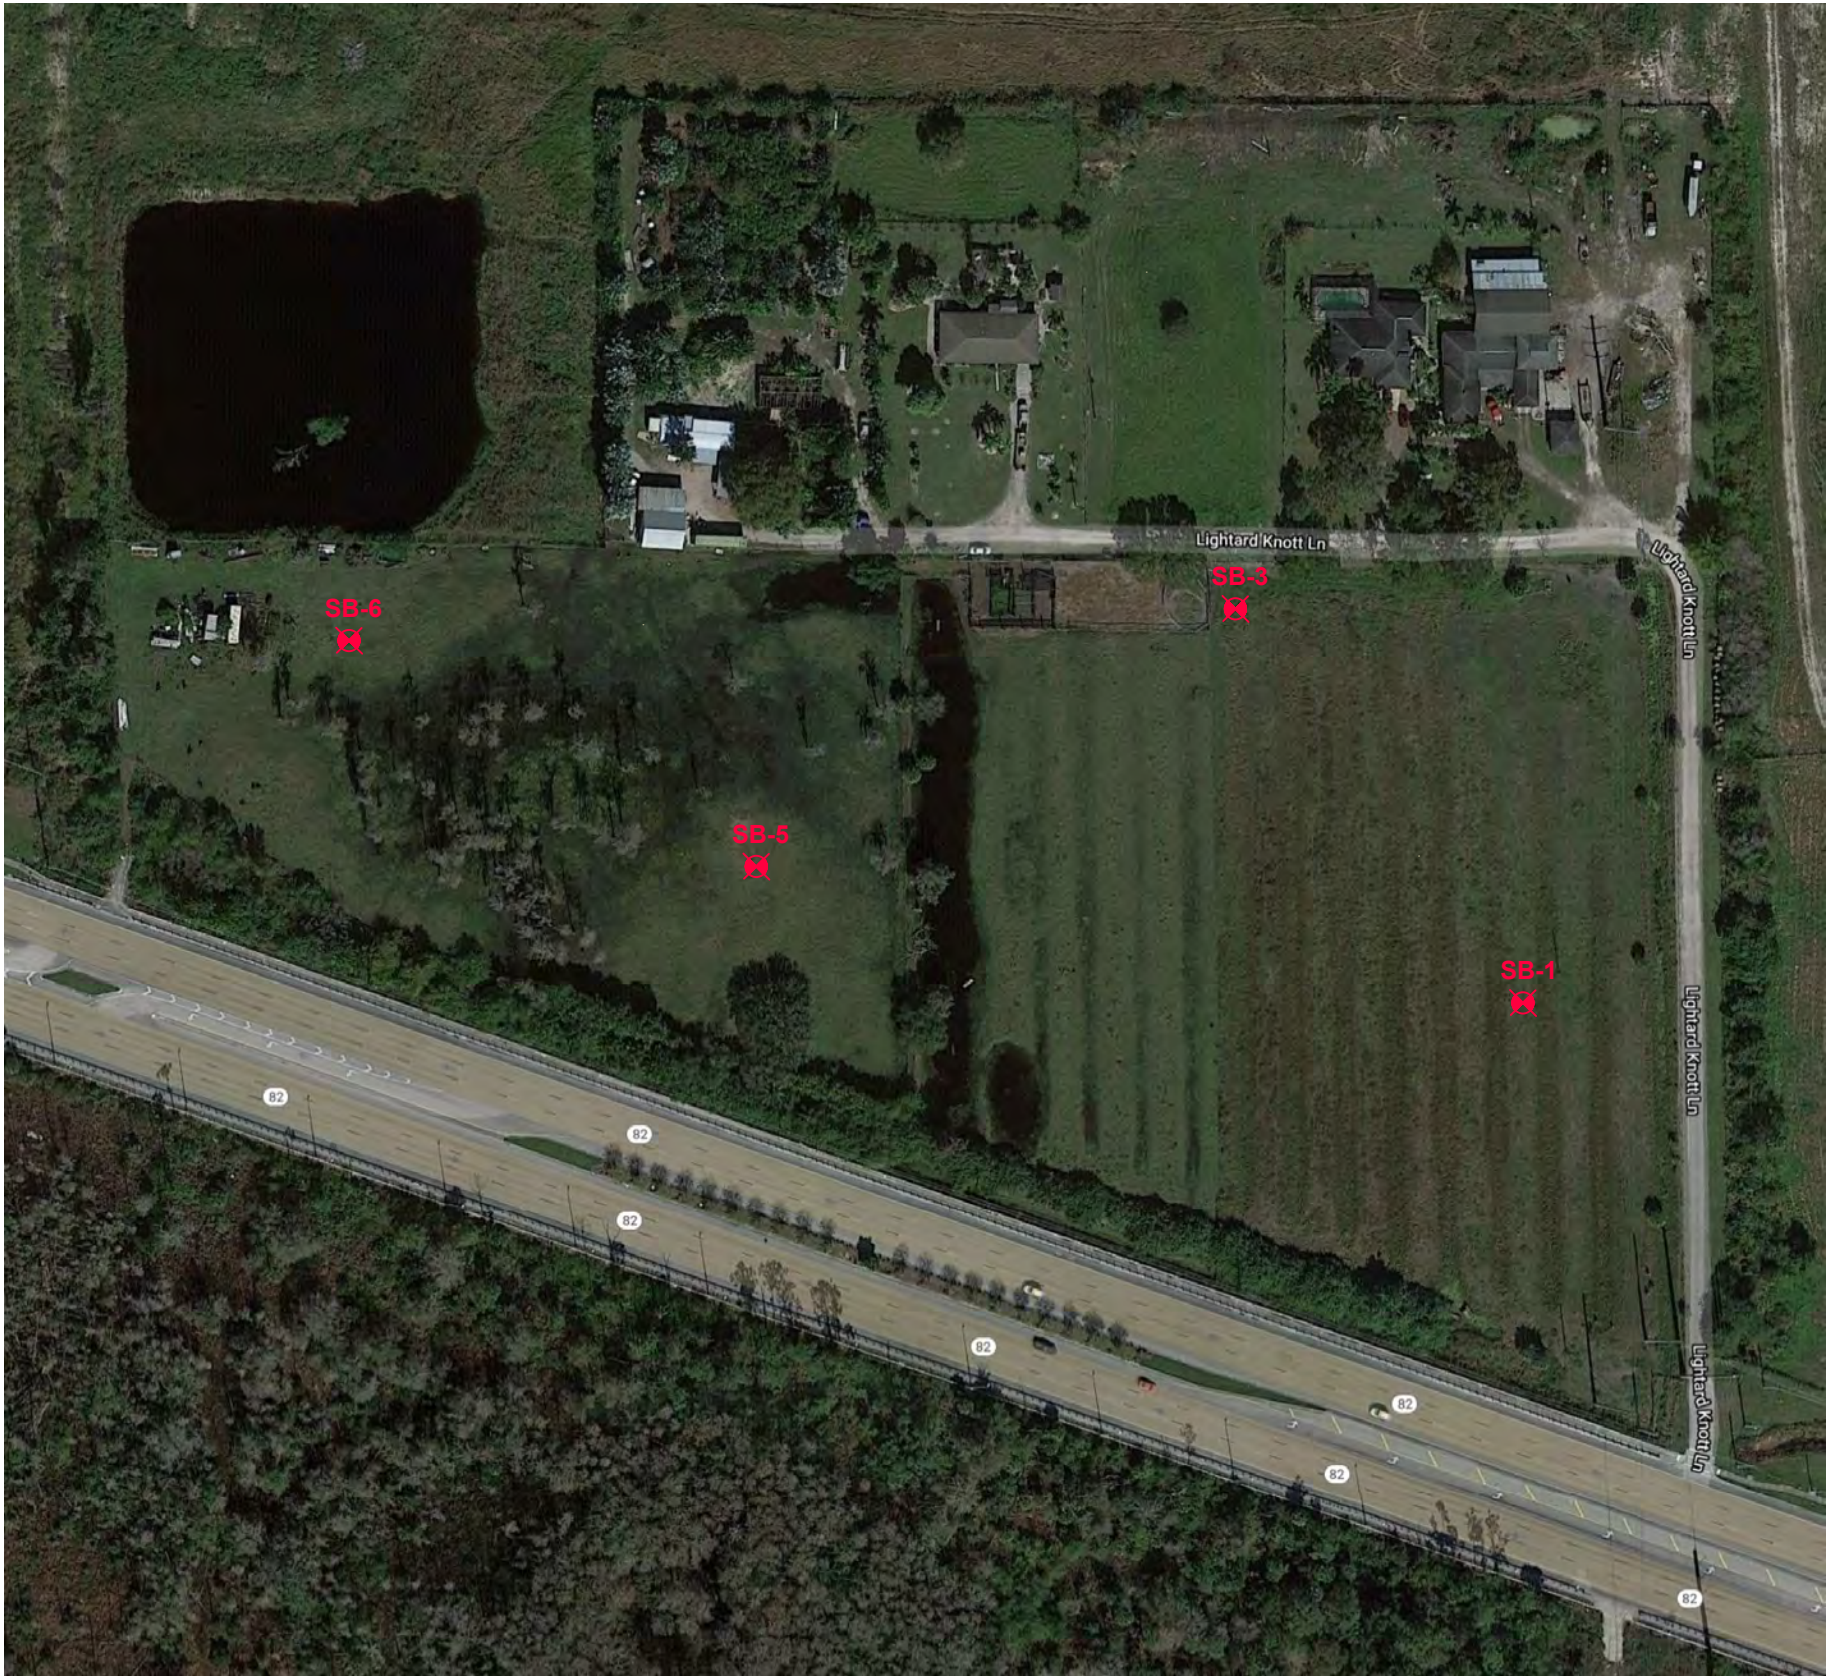
LEGEND	
SB-1 	Standard Penetration Boring(s) Location and Identification.

The analyses and recommendations submitted in this report are based upon the data obtained from field exploration program at locations indicated in the Project Layout and Test Location Plan presented in **Figure 2**, as well as any other information discussed in this report. In the performance of a subsurface exploration, specific information is obtained at specific locations at specific times. However, it is known that site and subsurface conditions can change over time. Additionally, variations in soil and rock exist on most sites between test locations. The nature and extent of such variations may not become evident until after the start of construction. If variations appear, it will be necessary to re-evaluate the recommendations of this report after performing on-site observations during the construction period and/or performing supplemental tests.
